QUATTROCCHI KWOK
ARCHITECTS

V1.0
FINAL
August 31, 2021

FACILITIES ASSESSMENT

Gravenstein Union School District

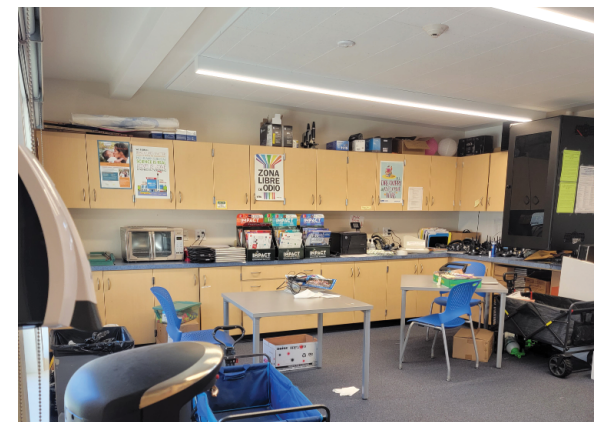
- Finishes: linoleum flooring is in good condition; areas with carpet are in good condition, but some rooms, like the staff room may require patching/replacement as it is an area with high traffic and use and is in poor condition. The wall and ceiling finishes appear to be in good condition.

Staff Breakroom

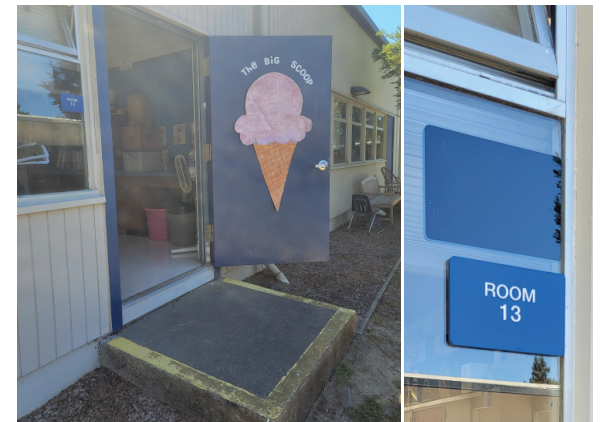
- Doors: doors are in good condition for the age of construction. Hardware is code compliant. Kick plates are present at some doors and are in fair condition. A secondary exit door is not in compliance, there is a ~6" drop to a concrete pad which drops 6" further into landscaped space between wings.

Classroom exterior non compliant doors/signage

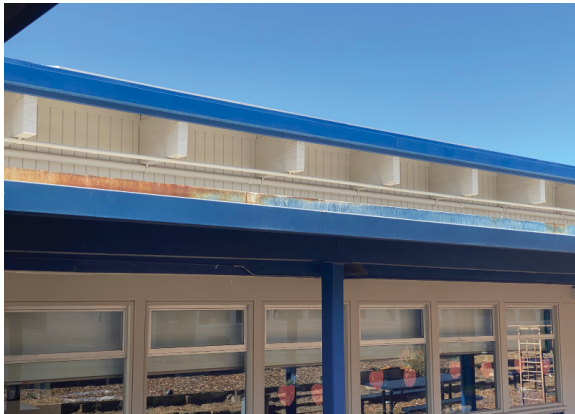
Corrosion at mechanical vents (exterior)

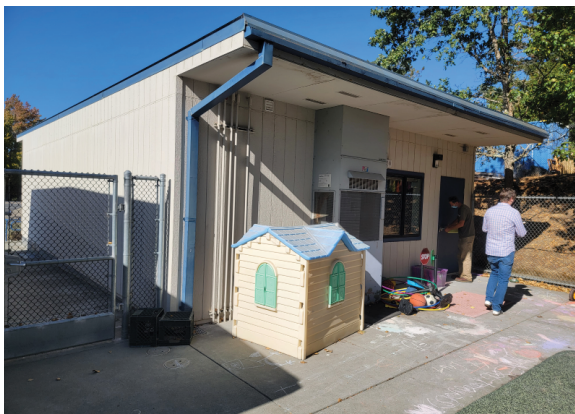
Exterior Building J - moisture intrusion at soffit

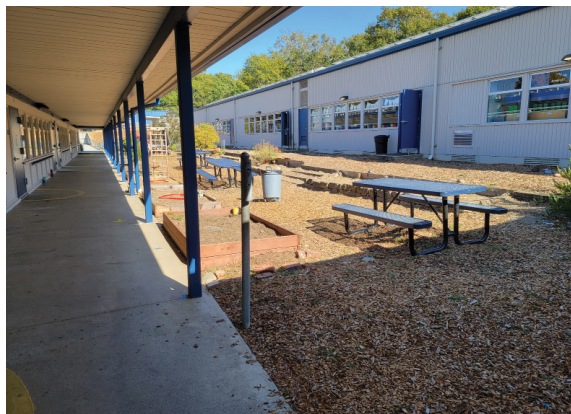
Exterior non accessible outdoor learning spaces

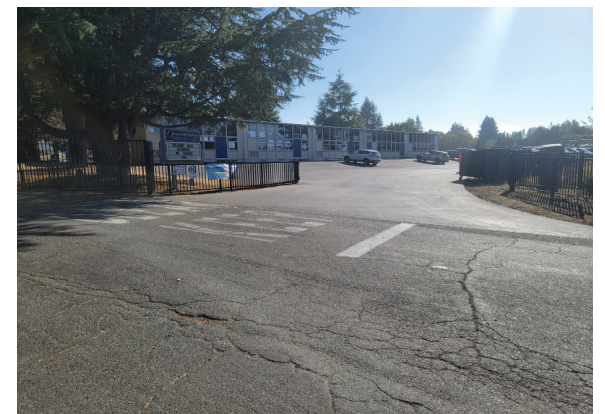
Arrival: There is a single crosswalk along Twig Avenue, but there is no safe pedestrian path into the school site. Pedestrian path and access design is recommended.

Arrival to site - missing safe pedestrian path

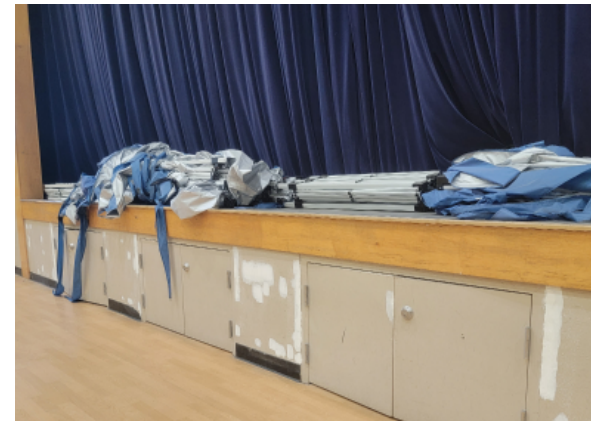
Area beneath stage in need of repair.

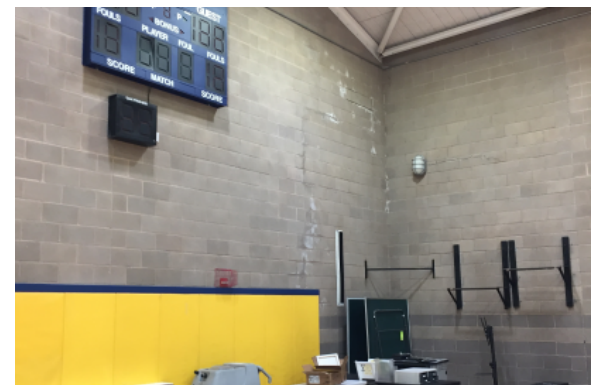
MPR Interior - Efflorescence at CMU

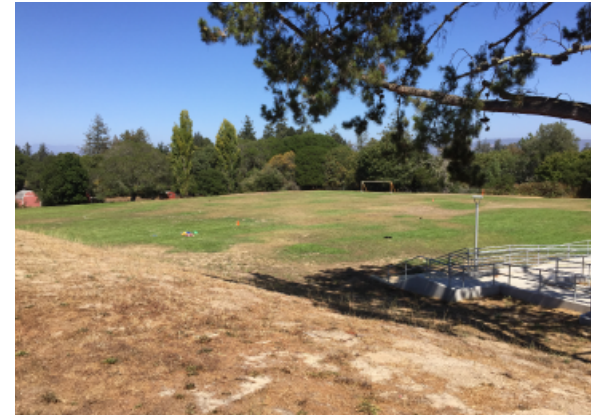
- Running track - no track currently exists.
- Playground improvements - update to reflect Middle School level and accessibility upgrades. Possibly include climber and natural play areas.
- New landscaping to improve curb appeal.
- ADA accessibility for classrooms - modernize current ramps to meet code.
- Provide additional storage for drama, PE. equipment and other facilities equipment.
- Future modernization work will require DSA review and approval of restroom dimensions as built.
- Replace exterior lighting fixtures.
- Seek funding to modernize the Multi-Purpose Building and Kitchen.

Existing field without track

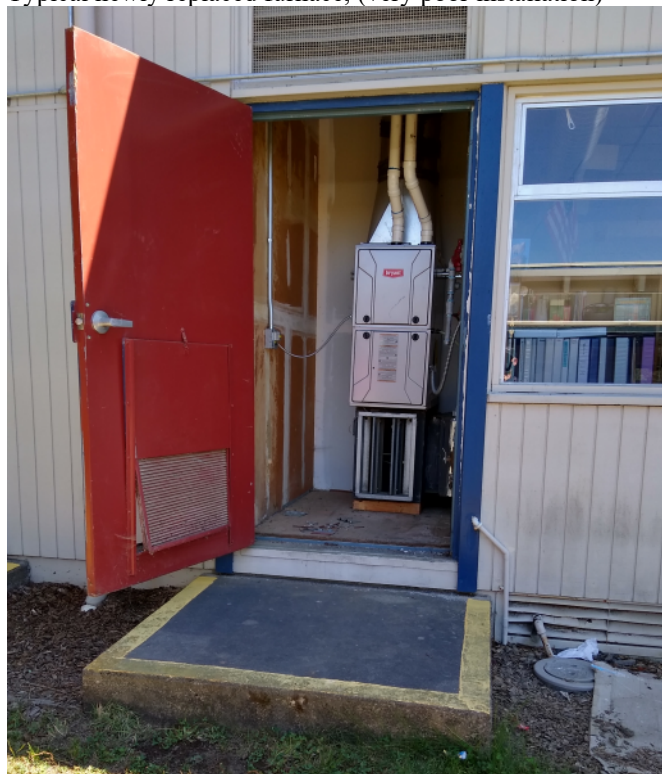
Typical newly replaced furnace, (very poor installation)

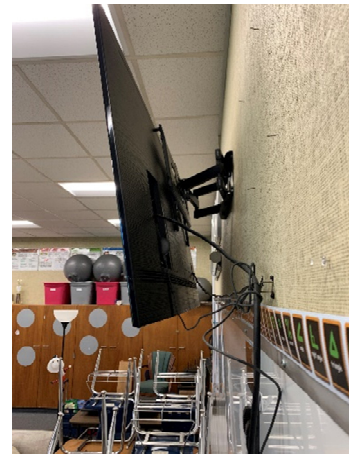
Typical Loose AV Cables
