GRAVENSTEIN UNION SCHOOL DISTRICT FACILITY MASTER PLAN

August 3rd, 2012
Prepared by:

4: HILLCREST MIDDLE SCHOOL

5: GRAVENSTEIN ELEMENTARY SCHOOL

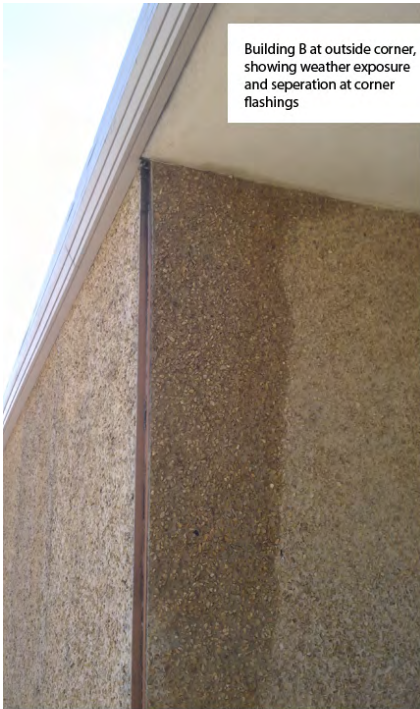
Building B at outside corner, showing weather exposure and separation at corner flashings

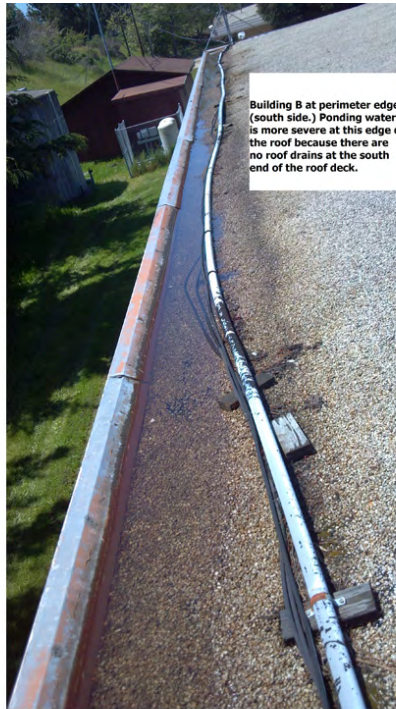
Building B at perimeter edge (south side.) Ponding water is more severe at this edge of the roof because there are no roof drains at the south end of the roof deck.

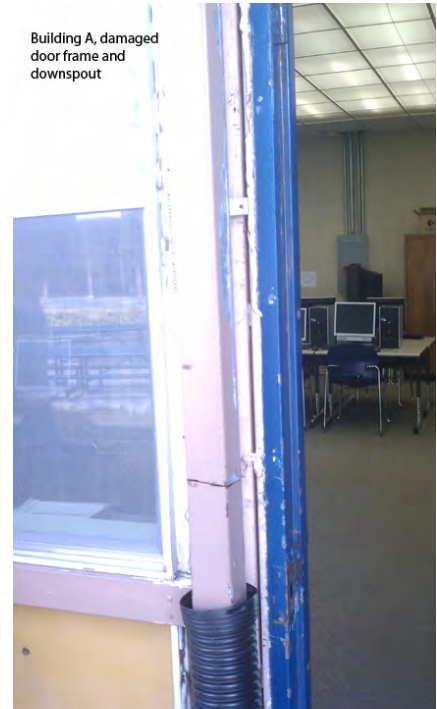
Building A, damaged door frame and downspout

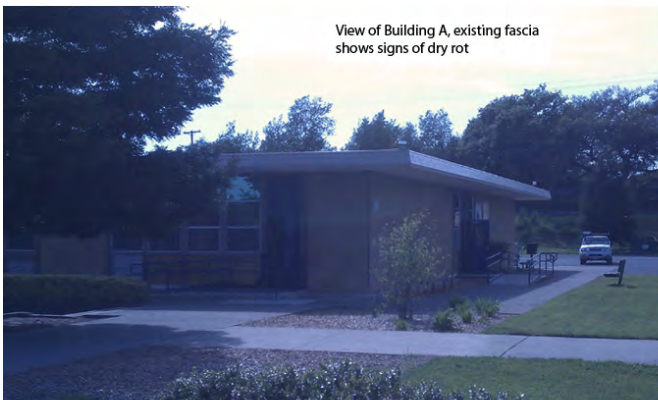
- Student pick-up areas lack shelter from the elements
 - The Principal's Office is removed from the Administrative Offices
- Dry rot noted in numerous locations

View of Building A, existing fascia shows signs of dry rot

3. Replace main switchboard for the campus
4. Addition of a new 6,000 SF +/- wing comprising the following classrooms:
(2) standard classrooms, (1) science classroom, (1) arts classroom, (1) music classroom
5. Not Used
6. Dry rot repair
 - a. Roof fascias
 - b. Exterior plaster corners
7. New pump house building
8. Repair of the storm drainage line on south and east ends of campus.

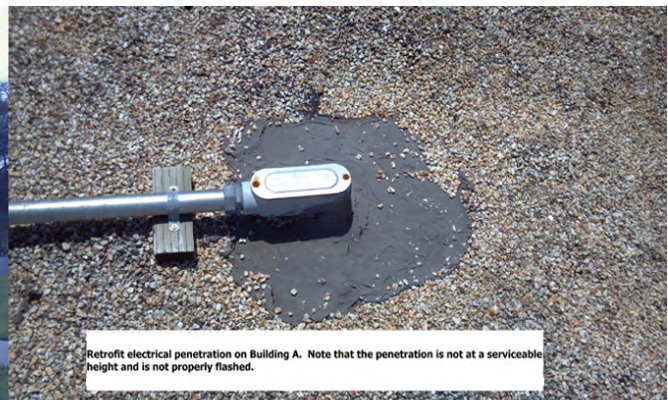
Retrofit electrical penetration on Building A. Note that the penetration is not at a serviceable height and is not properly flashed.

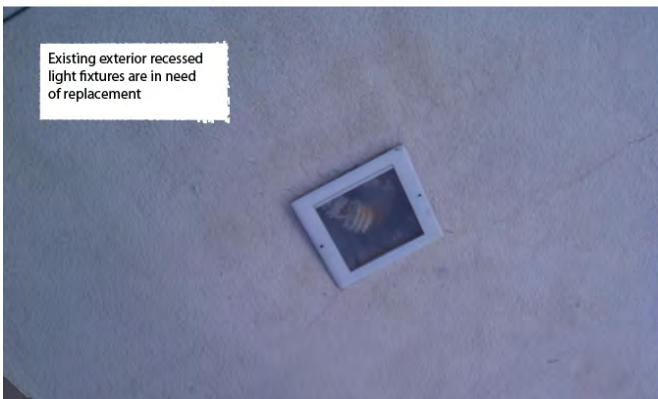
- Older T12 light lamps should be replaced
 - Fire alarm panel lacks addressable technology
 - Phone system is a discontinued outdated system
 - Public address system is non-operational

Existing exterior recessed light fixtures are in need of replacement

16. New electrical systems including the following:
 - a. Upgrade the PGE service
 - b. Replace lighting in parking lot
 - c. Light fixture replacements to incorporate T8 or T5 lamping

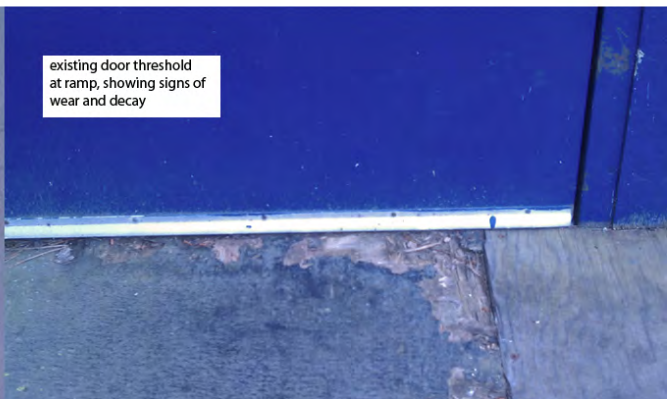
existing door threshold at ramp, showing signs of wear and decay

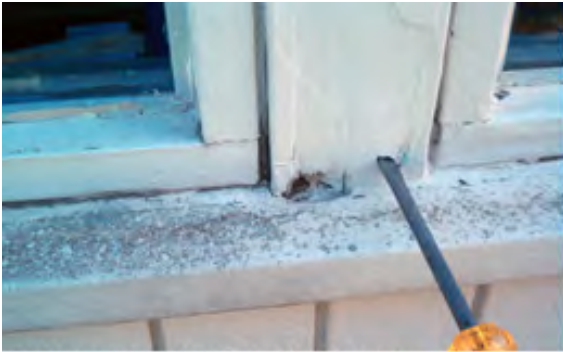
DRY ROT TYPICAL AT WINDOWS EXPOSED TO THE WEATHER

3. Modernize majority of classrooms in 2015 when the campus becomes eligible for state modernization funds
4. Install new roof assemblies
5. Dry rot repair
 - a. Roof fascia, walkway overhangs, window walls, wood sills

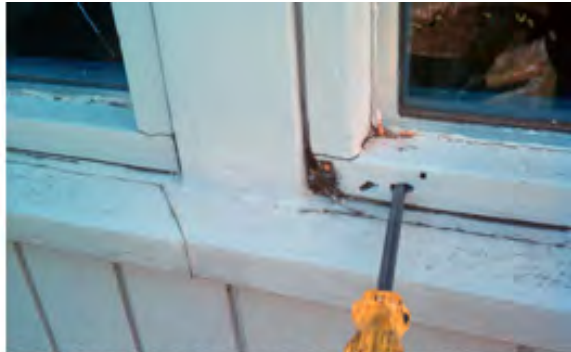
DRY ROT TYPICAL AT EXPOSED WINDOW FRAMES

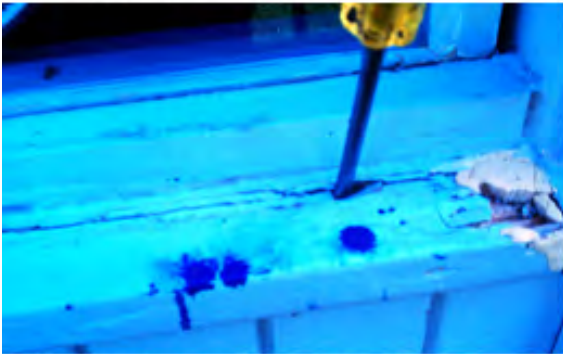
DRY ROT TYPICAL AT EXPOSED WINDOW SILL WHERE NO OVERHANG OCCURS

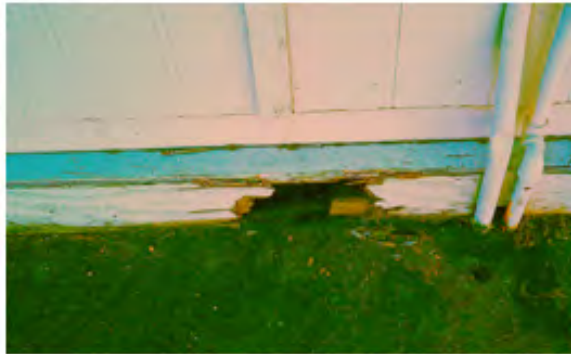
TYPICAL BUILDING FLOOR SILL PLATE IN CONTACT WITH GRADE. THIS WAS OBSERVED PRIMARILY AT THE EAST ENDS OF BUILDINGS A,B AND ADMIN

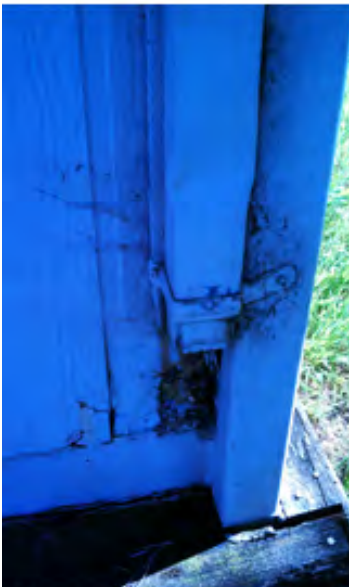
DAMAGED RAIN LEADER AND SURROUNDING FINISH MATERIALS

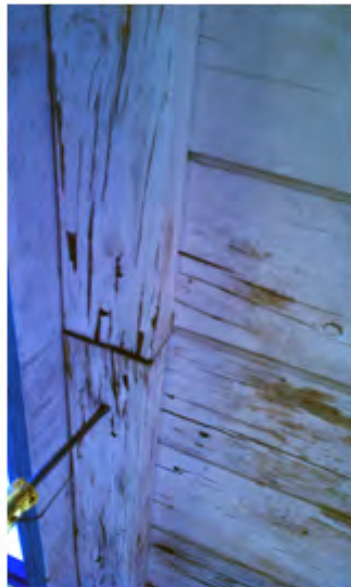
DRY ROT AT SIDING TRIM OBSERVED PRIMARILY AT BUILDINGS C, AND D

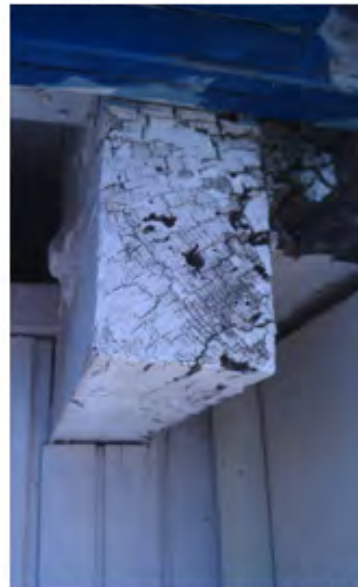
DRY ROTTING ROOF BEAM OBSERVED AT VARIOUS LOCATIONS

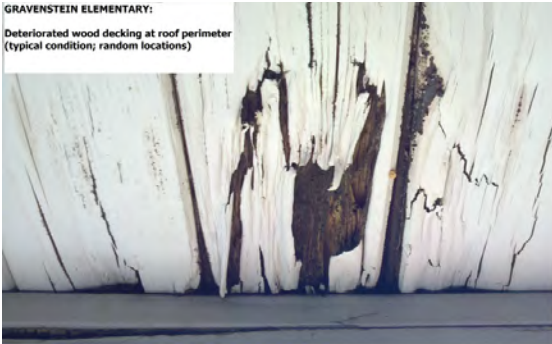
Deteriorated wood decking at roof perimeter (typical condition; random locations)

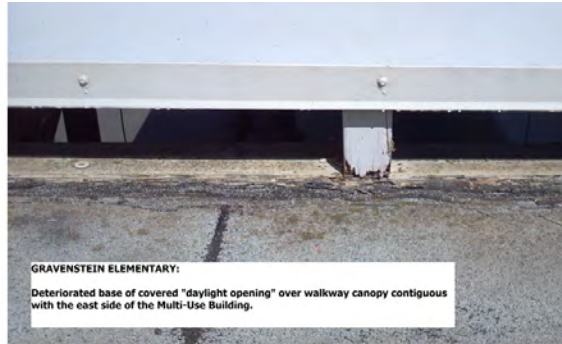
Deteriorated base of covered "daylight opening" over walkway canopy contiguous with the east side of the Multi-Use Building.

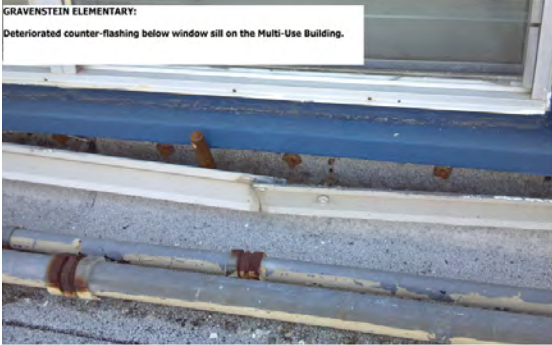
Deteriorated counter-flashing below window sill on the Multi-Use Building.

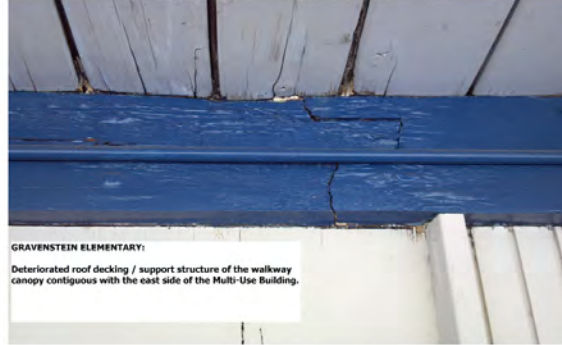
Deteriorated roof decking / support structure of the walkway canopy contiguous with the east side of the Multi-Use Building.

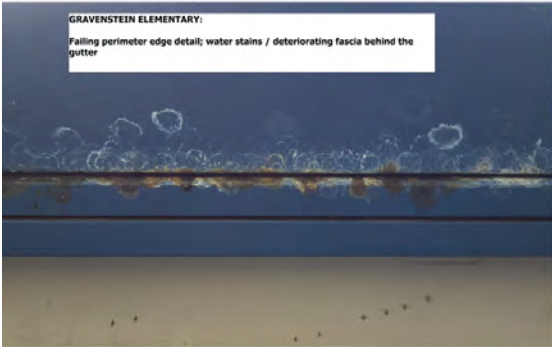
Falling perimeter edge detail; water stains / deteriorating fascia behind the gutter

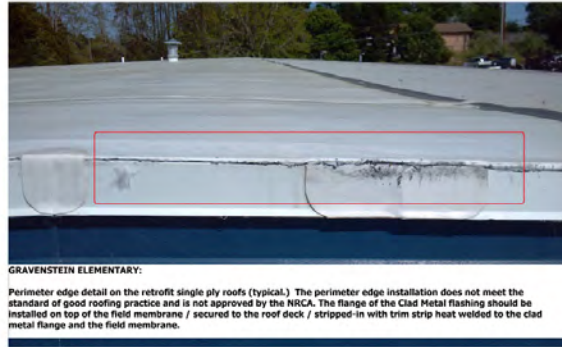
Perimeter edge detail on the retrofit single ply roofs (typical.) The perimeter edge installation does not meet the standard of good roofing practice and is not approved by the NRCA. The flange of the Clad Metal flashing should be installed on top of the field membrane / secured to the roof deck / stripped-in with trim strip heat welded to the clad metal flange and the field membrane.

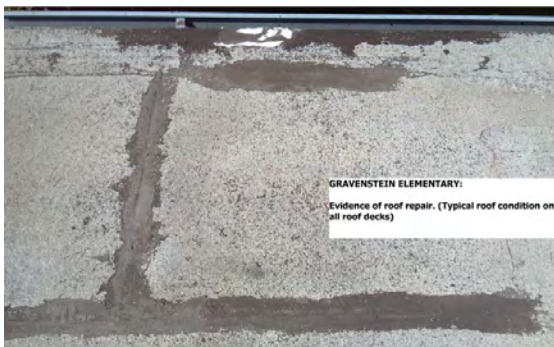
GRAVENSTEIN ELEMENTARY:
Evidence of roof repair. (Typical roof condition on all roof decks)

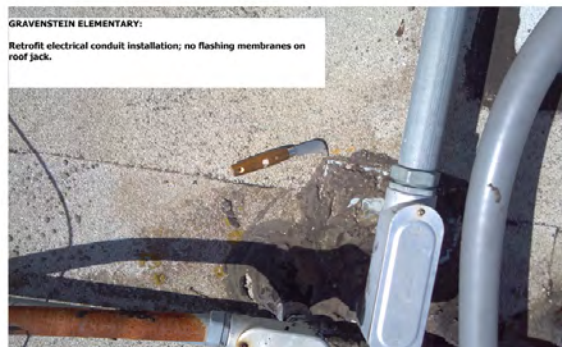
Retrofit electrical conduit installation; no flashing membranes on roof jack.
