QUATTROCCHI KWOK
ARCHITECTS

V1.0
FINAL
August 31, 2021

FACILITIES ASSESSMENT

Gravenstein Union School District

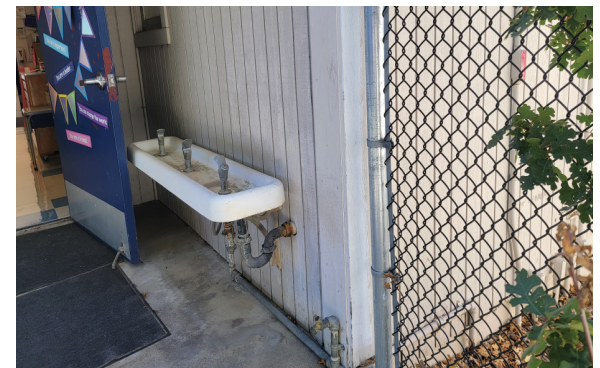
- Pedestrian Access: building entrances are located on the exterior facade with direct access to exterior walkways. Thresholds meet accessibility requirements.
- Classroom Sinks: Cabinet doors in place preventing ADA clearance for toe space/approach, recommend removing doors for compliance. Exterior drinking fountains are in poor condition.
- Signage: code compliant signage installed.

Kinder drinking fountain

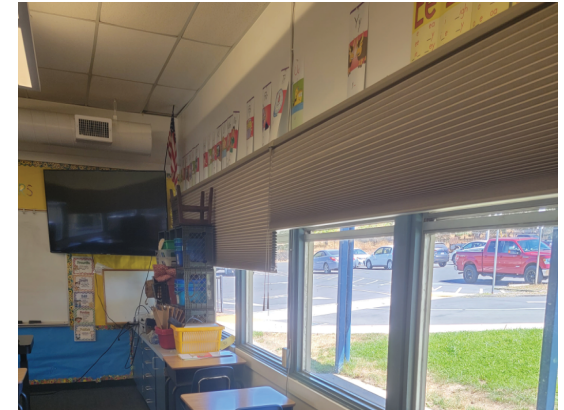
- Finishes: floor is in fair condition with areas that may require replacement. Select rooms have upgraded carpet as part of a maintenance upgrade. The wall and ceiling finishes appear to be in good condition. Ceilings tiles and LED pendant lighting in place appear newer.
- Cabinets and Furnishings: some cabinets show signs of normal wear and tear, but they are generally in fair to good condition. Counter-tops are in good condition with plastic laminate replacement.
- Storage: some classrooms were cluttered at the time of evaluation. Unsafe storage on tall cabinets.
- Window Coverings: accordion manual shades are in fair condition considering the age of the building. Would recommend replacing with upgraded manual roller shades.

Classroom windows/window coverings

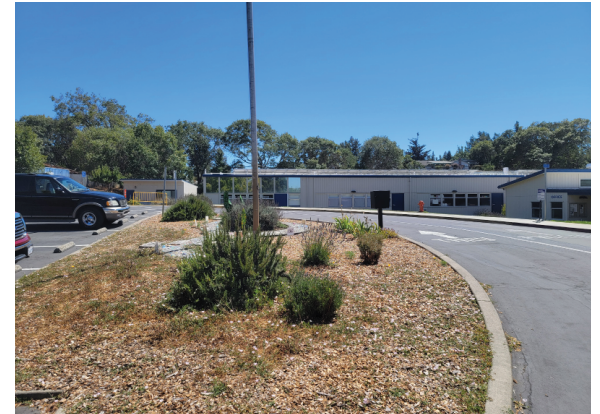
Student Drop-off

Arrival: There is a single crosswalk along Twig Avenue, but there is no safe pedestrian path into the school site. Pedestrian path and access design is recommended.

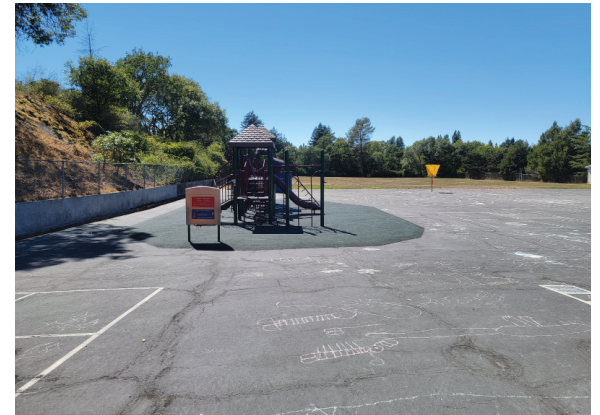
AC paving at playground

- Playground improvements to incorporate a poured in place solution in lieu of bark wood chips as it is difficult to maintain accessibility standards with bark.
- Upgrade playground equipment
- Improvements to student sports fields and track

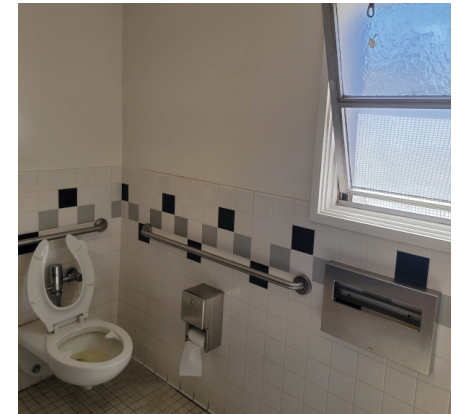
Minor accessibility issues (window protrusion exceeds 4")

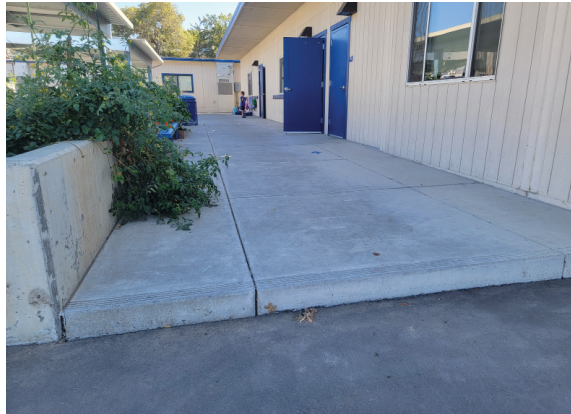
- Pedestrian Access: building entrances have direct access to exterior compliant hardscape that leads to compliant covered entry and covered lunch structures. Thresholds are in conformance. The north most access to the buildings is not ADA compliant, there is about a 6" drop; this could be a fall hazard, recommend railing. Library space appears to have some trip hazards(cables) and may have areas where accessible path is obstructed.
- Signage: code compliant signage installed.

Non-accessible path at Building G to playground

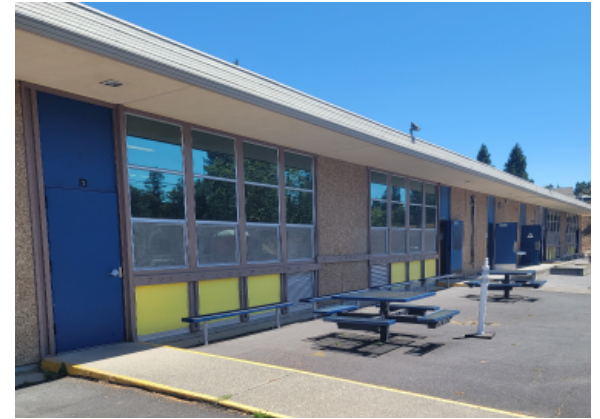
- Roof: gravel surface BUR roofing is in poor condition and replacement is recommended. Perimeter ponding is a major issue, flashings at penetrations have failed, not insulated, and does not meet Title 24. Future roofing replacement scheduled for Summer 2022.
- Exterior Cladding: building exterior is marblecrete and appears to be in fair condition for the age of building. Exterior plaster on outside corners, moldings, caulking rot.
- Soffits: Cement plaster soffits appear to be in fair condition with old recessed lighting in poor condition.
- Windows: interior hollow metal windows with wire mesh appear to be in fair condition. Exterior windows appear to be new aluminum operable windows and have manual window shades.
- Doors: doors are in fair condition for the age of construction. Hardware is code compliant (verify).

Exterior of Building

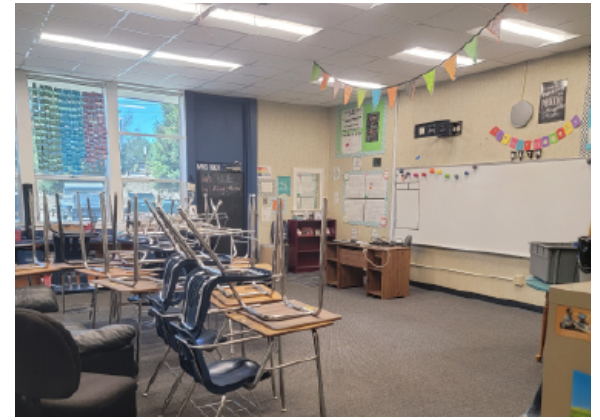
Maker Lab Interior (Classrooms similar)

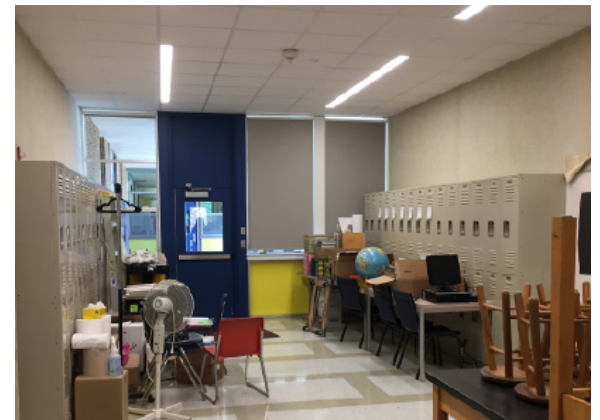
Typical "Hall" Interior

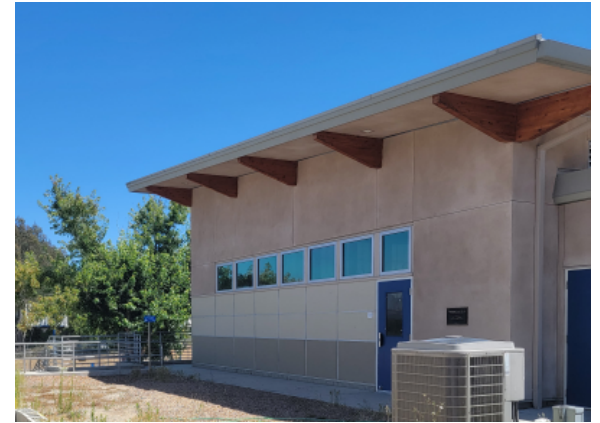
- Roof: TPO roofing installed over original roof is in fair condition for its age.
- Exterior Cladding: building exterior is cement plaster and appears to be well-maintained and is in good condition for the age of building. At the time of evaluation, there was no evidence of moisture or insect intrusion.
- Windows: windows are aluminum awning units and appear to be in good condition. Windows appeared operable with no signs of leaks at the time of evaluation.
- Doors: doors are in good condition for the age of construction. Hardware is code compliant.

Exterior of Building

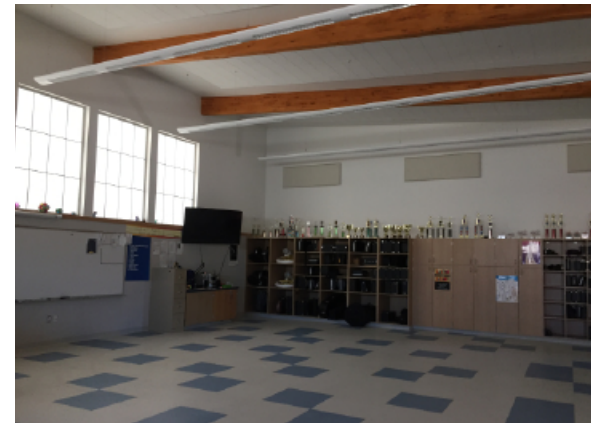
The Music Classroom is in good condition.

Music Classroom

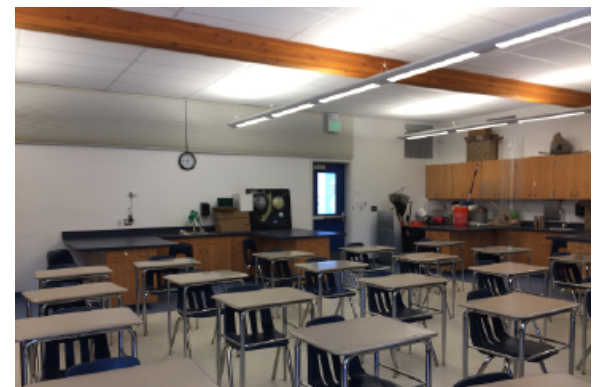
The Science Classroom and Prep Room are in good condition. There is some evidence of wear and tear at interior cabinets.

Science Classroom

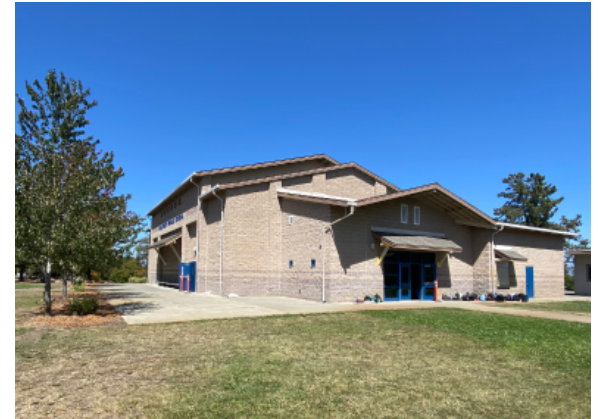
- Roof: shingle roof is in fair condition for its age. Perimeter sheet metal flashing is in good condition. Shingles are at about 85% life expectancy; consider planning to replace roof.
- Exterior Cladding: building exterior is CMU and appears to be well-maintained and is in good condition for the age of building. There is some cement plaster finish located between the low and high roofs.
- Windows: windows are painted hollow metal units with tempered glazing and appear to be in good condition. Windows do not appear operable.
- Doors: doors are in good condition for the age of construction.

Exterior of Building

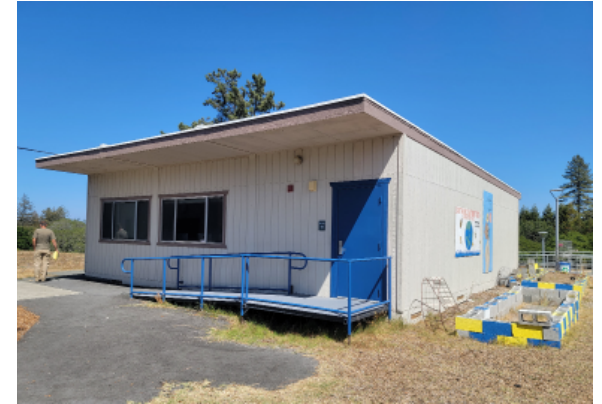
The portable building has been well-maintained on the interior and is in fair condition for its age. There is evidence of normal wear and tear at the interior cabinets, floors and walls. The exterior siding is worn, and the doors show significant wear.

- Roof: metal standing seam roof is in fair condition for its age. TPO roof coating installed summer 2019.
- Exterior Cladding: building exterior is vertical wood siding and appears to be in poor to fair condition. The building sits on wood blocking on top of ac. Requires maintenance to paint and caulk building, and good drainage to extend the life of the building.
- Exterior Soffit: the exterior soffit is in poor to fair condition, showing some discoloration and wear.
- Windows: windows are dual glazed, horizontal sliding anodized aluminum units and appear to be in fair condition. Windows appeared operable with no signs of leaks at the time of evaluation.
- Doors: doors are in poor to fair condition for the age of construction.

Exterior of Portable Building

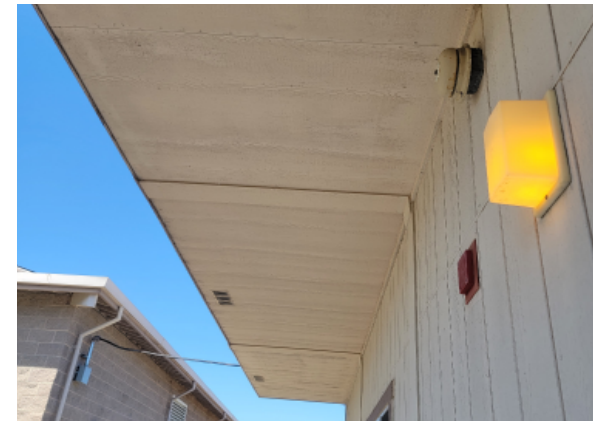
Exterior Soffit

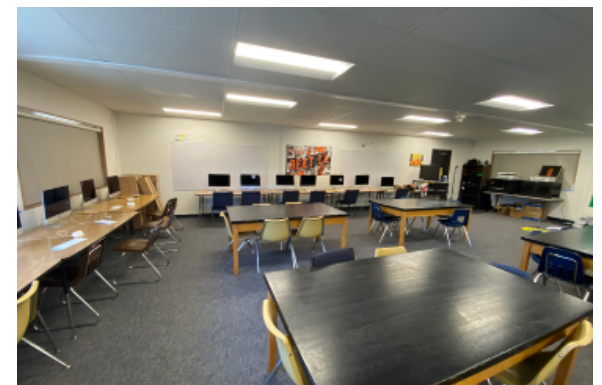
- Finishes: floor is in fair to good condition. The walls are in fair condition, and ceiling tiles appear to be in fair condition, with some wear/dark spots and some missing/removed tiles that need to be replaced.
- Casework and Furnishings: Tall cabinets are outdated and in poor condition. Furniture appears to be in fair condition.
- Electrical - not enough outlets.

Portable Interior

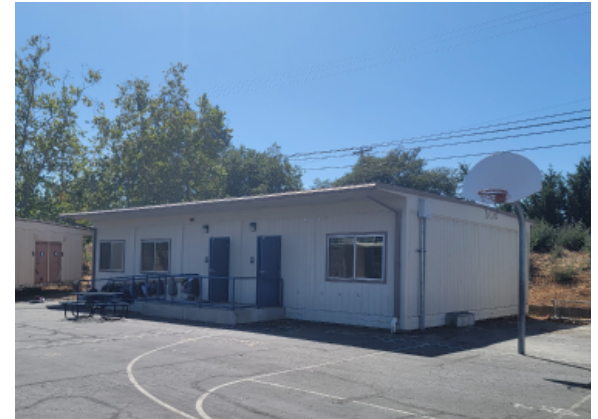
Overall portable building has been well-maintained and is in fair to good condition for its age. The classrooms share one ramp, and there are backpack hooks on the exterior. There is evidence of some normal wear and tear at the exterior.

Exterior of Portable Building

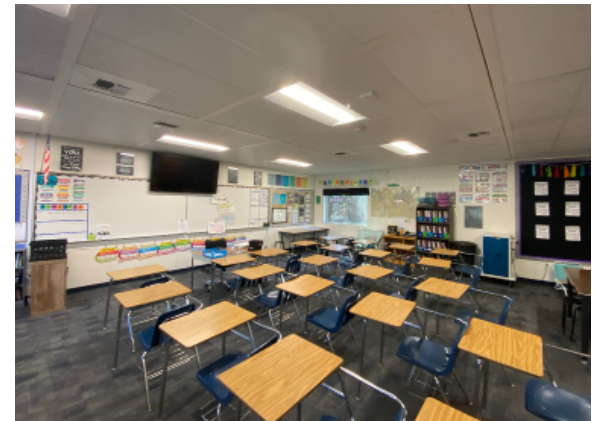
P1 Classroom is in good condition. There is evidence of normal wear and tear at the interior cabinets, plumbing/sink fixtures, linoleum flooring and walls. Most of the ceiling tiles appear in fair to good condition, but some have dark/worn areas adjacent to mechanical vents.

P1 Classroom Interior

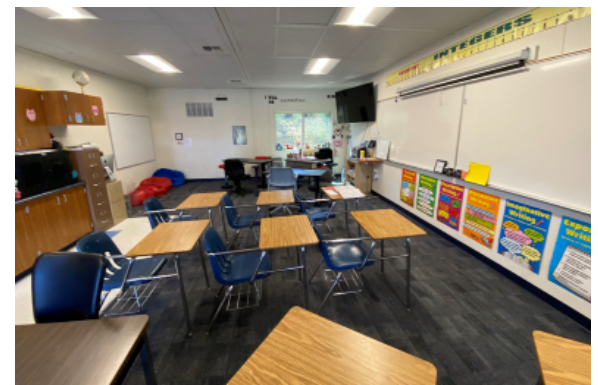
P2 Learning Lab is in good condition, and condition is similar to the P1 Classroom.

P2 Learning Lab Interior

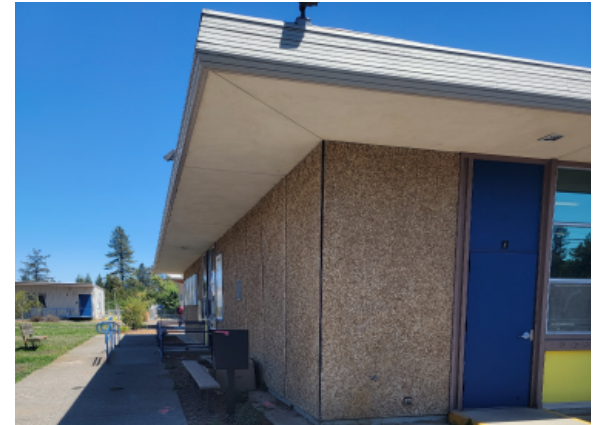
Fascia Boards

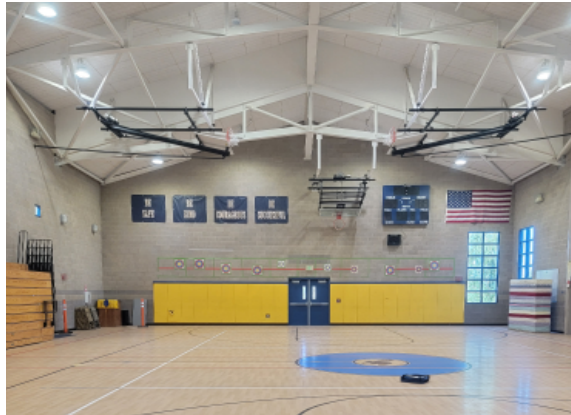
The main Multi-Purpose Room space is worn, with some stains and damaged finishes. Bleaches appear in good condition.

MPR Interior

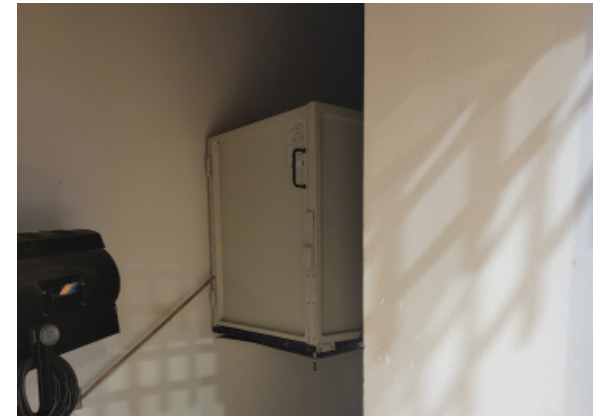
Wheelchair lift to Stage

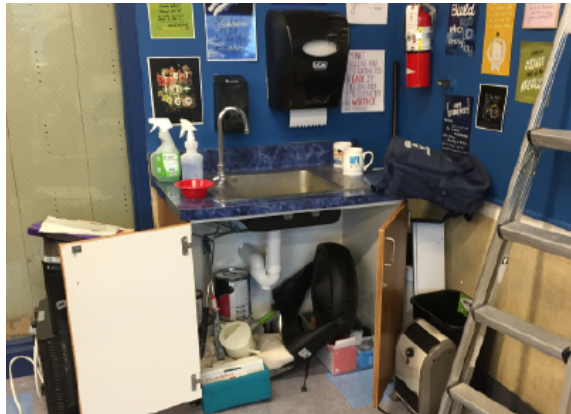
Classroom Sink - Not Accessible

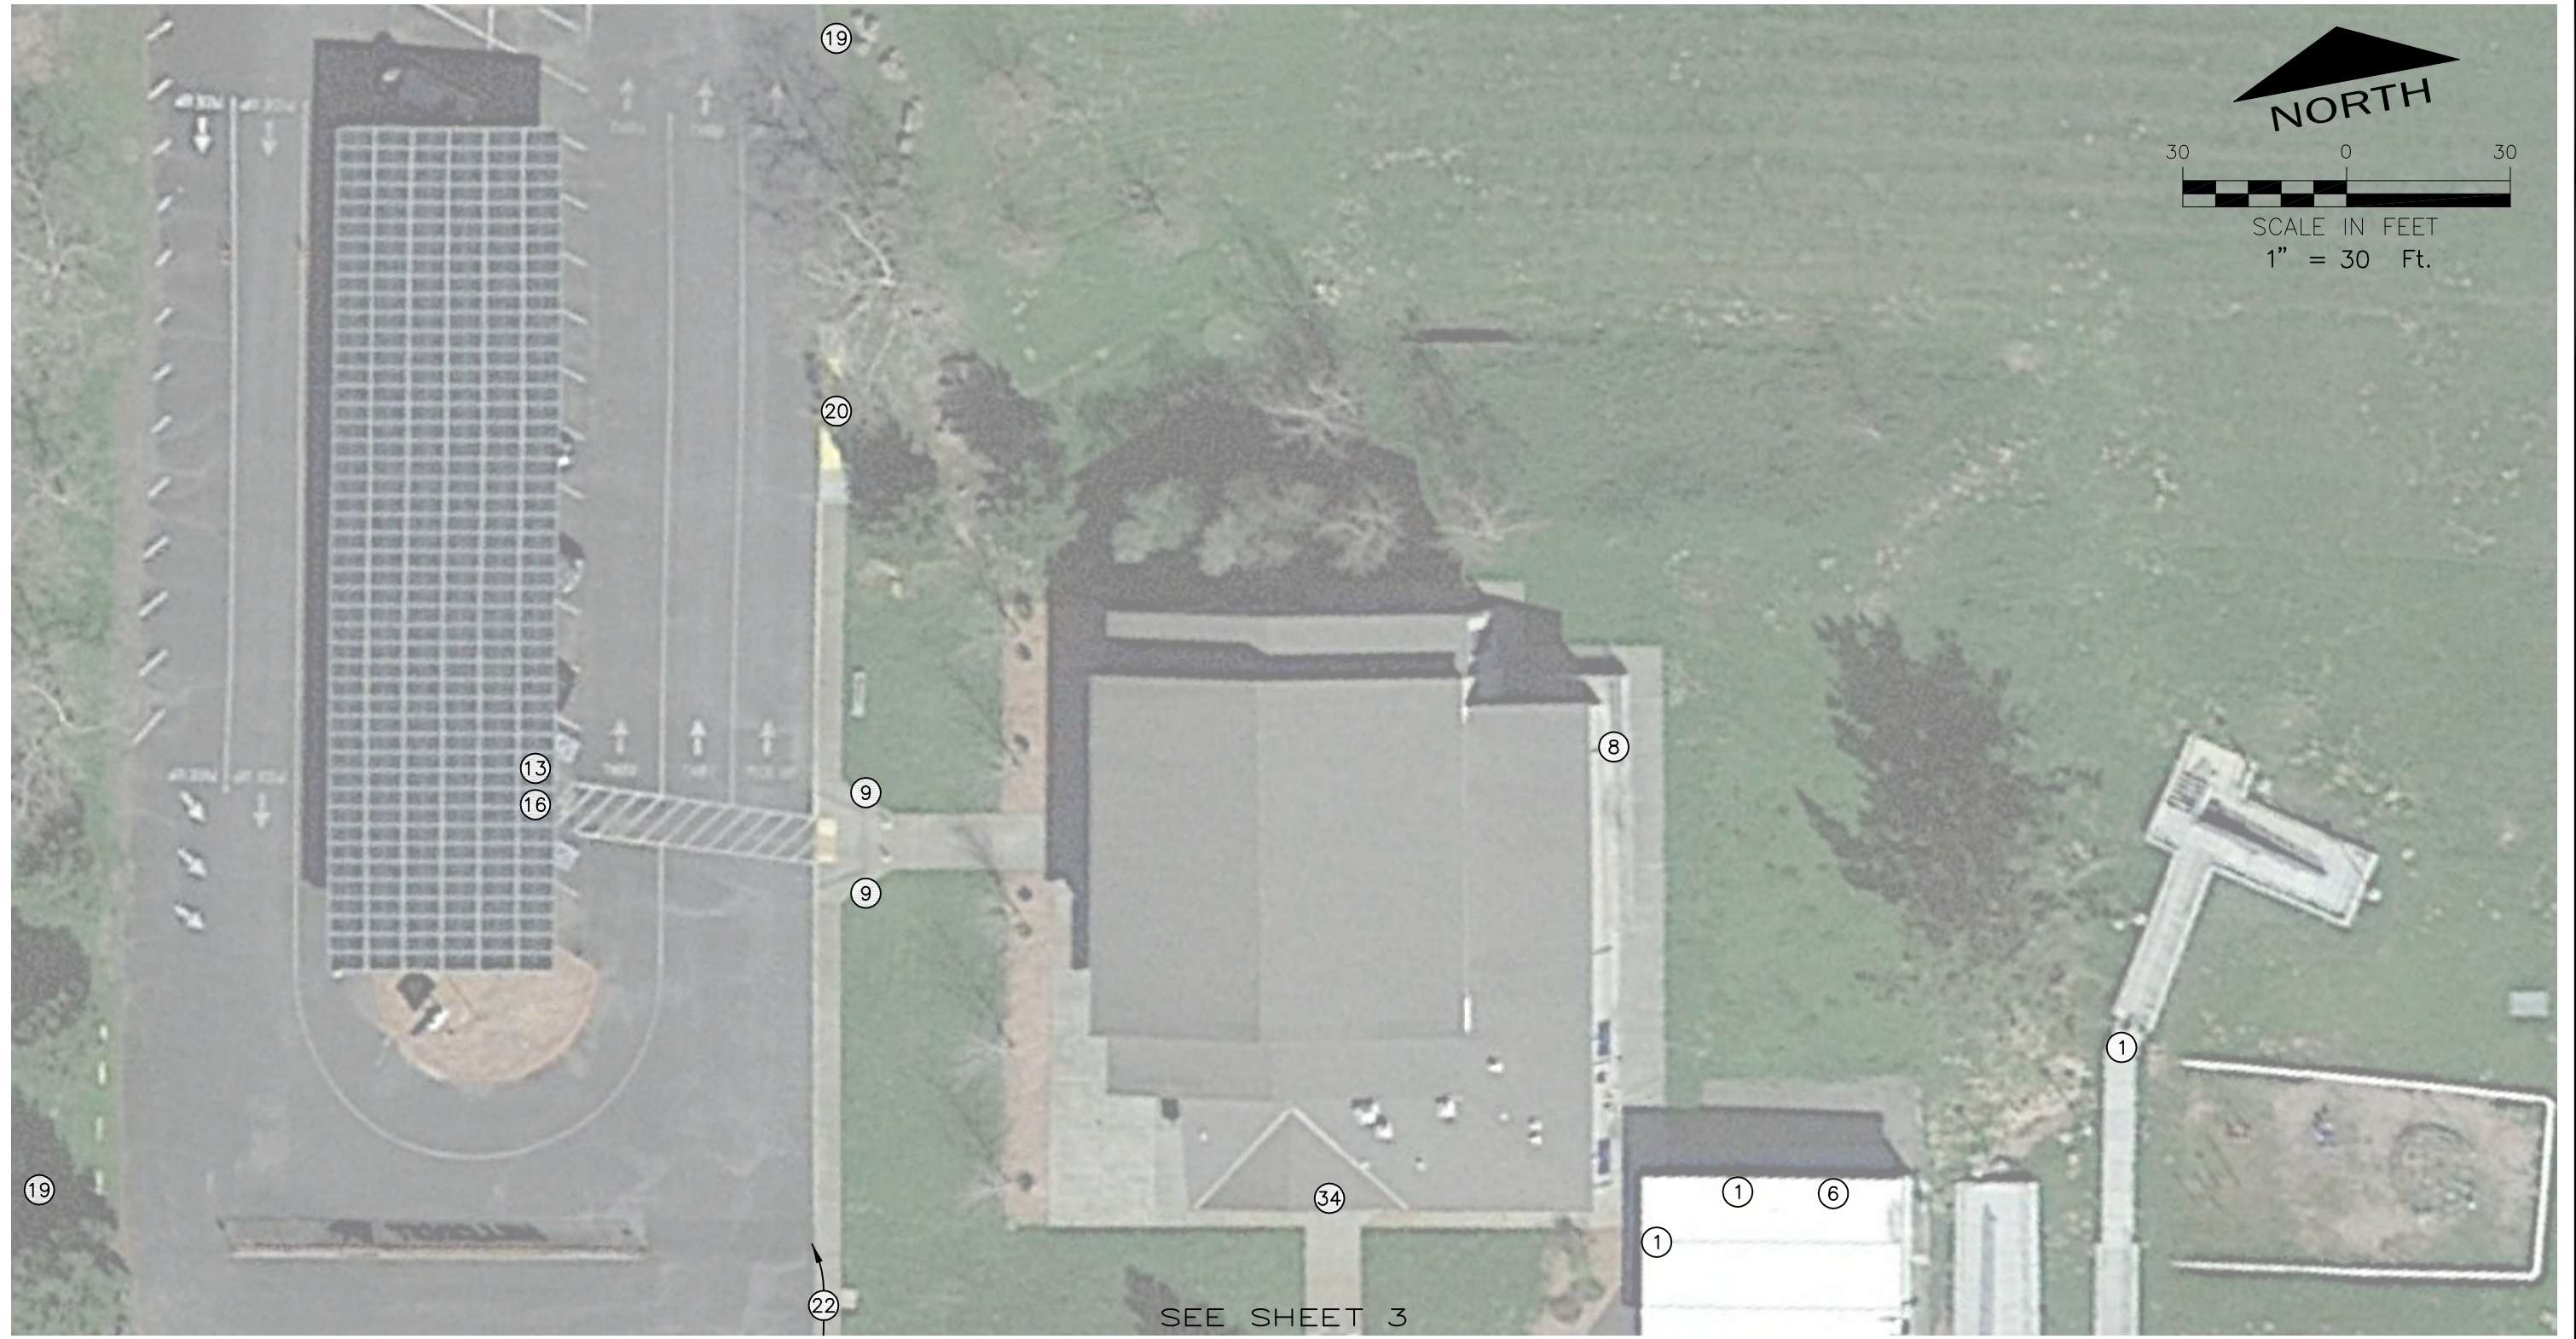
**GRAVENSTEIN UNION SCHOOL DISTRICT
HILLCREST MIDDLE SCHOOL**

- ④ TRAVEL WAY CROSS SLOPES EXCEEDS 2%.
- ⑤ TRAVEL WAY SLOPE EXCEEDS 5% WITHOUT HANDRAILS.
- ⑥ RAMP SLOPE EXCEEDS 8.33%.
- ⑦ NON COMPLIANT/MISSING RAILINGS FOR RAMPS.

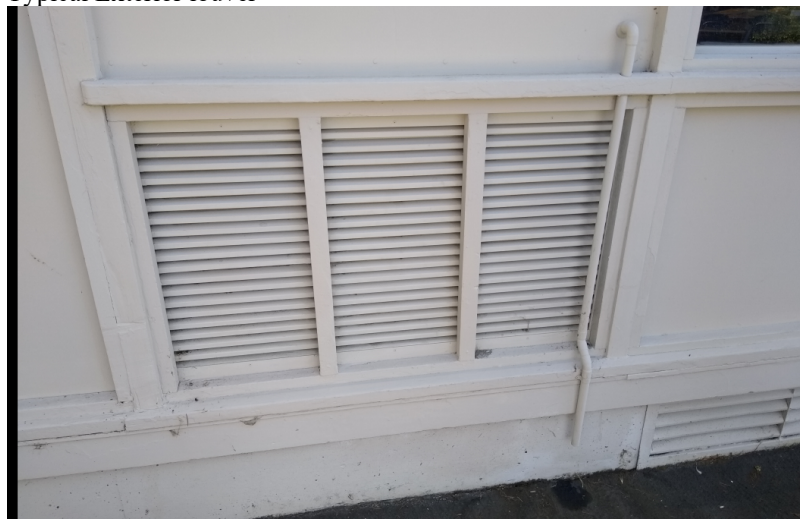
Typical Exterior louver

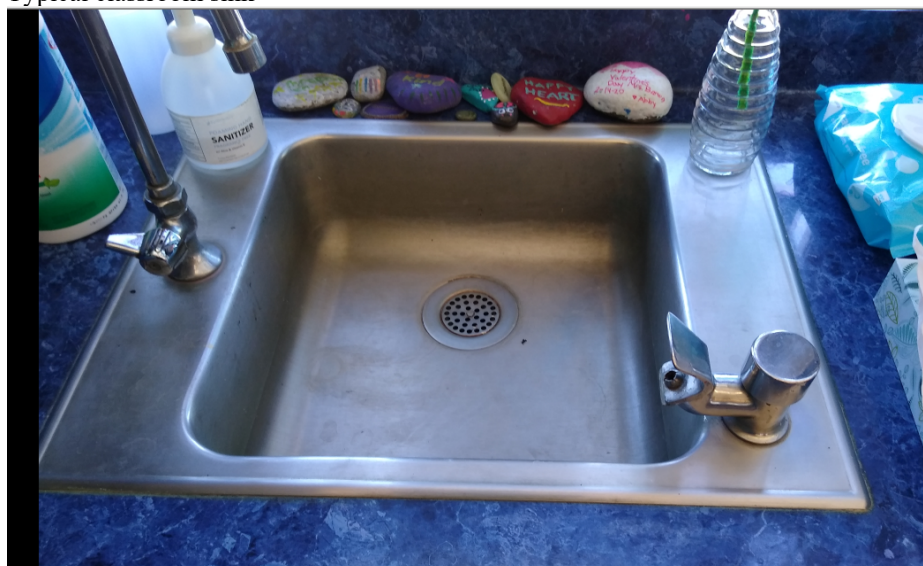
Classroom sinks are stainless steel, cold water only with bubblers. They appear to be original vintage and could stand to be replaced. The faucet handles are non-wrist blade type and the clearance below is questionable for ADA. These should be replaced.

Typical classroom sink

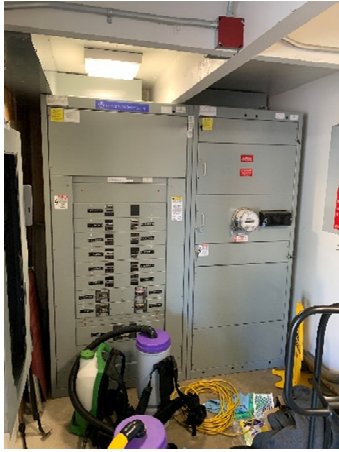
Main Electric Service Panel

The electric service is rated 600A, 120/208V, 3-Phase, 4-Wire, and was installed in 2016, as manufactured by General Electric Corporation. The equipment includes a photovoltaic system interconnection and is in good condition. No remedial action is required for the electric service, although the amperage size may be small for this size campus. Current PG&E billing history can be utilized to review the available spare capacity, if needed.

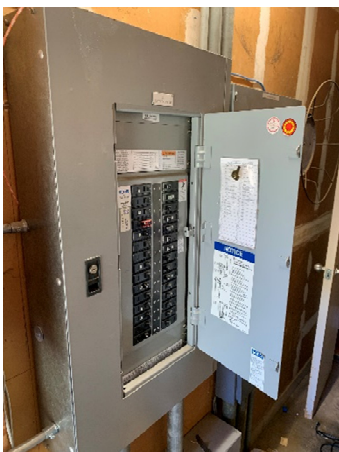
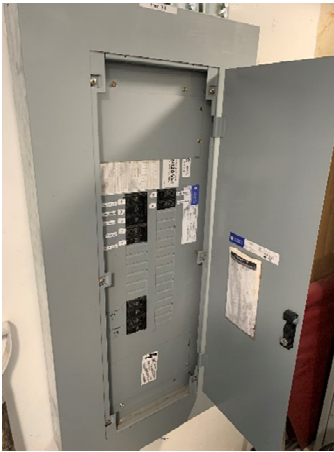
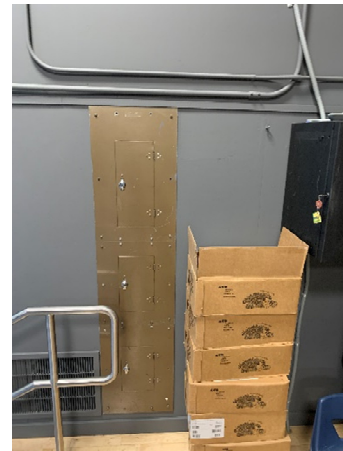
Branch Panels

The buildings panels are of a recent vintage and are in good condition. Panel directories include both typed and hand-written entries made over time, which could be updated for easier maintenance in the future, if desired by the District.

No code violations or DSA action items were noted for the various panel boards.

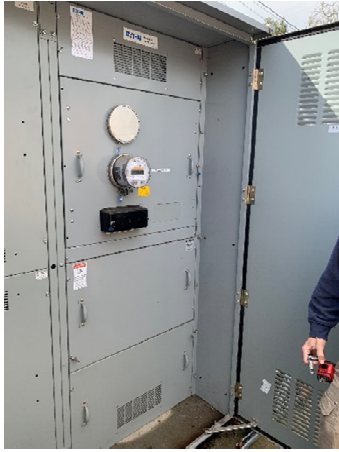
Main Electric Service Panel

The electric service is rated 1,200A, 120/208V, 3-Phase, 4-Wire, and was installed in 2017, as manufactured by Eaton Corporation. The equipment includes a photovoltaic system interconnection and is in good condition. No remedial action is required for the electric service.

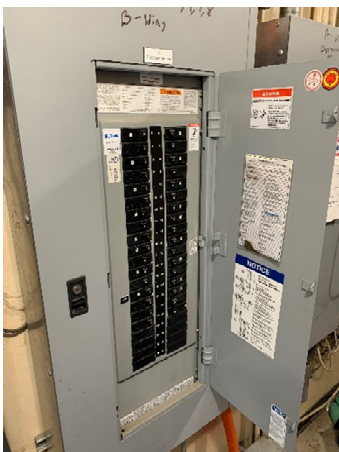
Branch Panels

The buildings panels are of a recent vintage and are in good condition. Panel directories include both typed and hand-written entries made over time, which could be updated for easier maintenance in the future, if desired by the District.

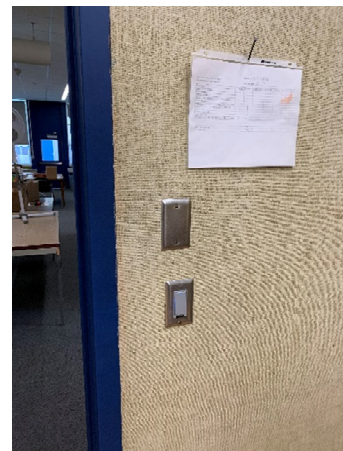
Modern Dimmer Switches

Newer areas, such as the common spaced between classrooms, have been provided with Title 24 compliant controls, to include motion sensing and dimming control instead of multi-level switches. There were no automatic daylight dimming photosensors observed.

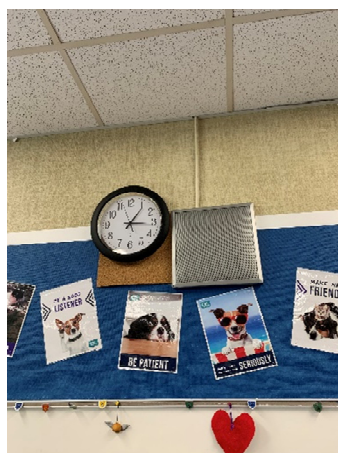
Typical Clock/Speaker

Clocks are all wall mounted, battery operated, atomic style. There is no central clock system.

While the system is reportedly working properly, upgrades could be considered to an IP based network system for both clocks and speakers, if the District wants more flexible control from a central location like an Admin PC. Systems are available where the clock/speakers run on a Power over Ethernet (PoE) cable on the data network, and are controlled by an Admin PC and server, vs hard wired speakers and battery clocks. There is no need to upgrade at this time, however.

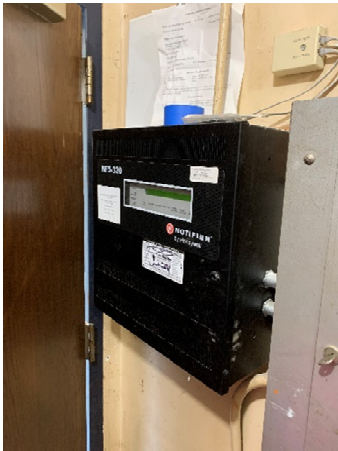
Main FACP

The system is operational and does not need any changes at this time, unless modernization or renovation work is undertaken in an area.
