# HILLCREST MIDDLE SCHOOL

## HEAT MITIGATION STUDY

Prepared for Gravenstein Union School District

October 2020

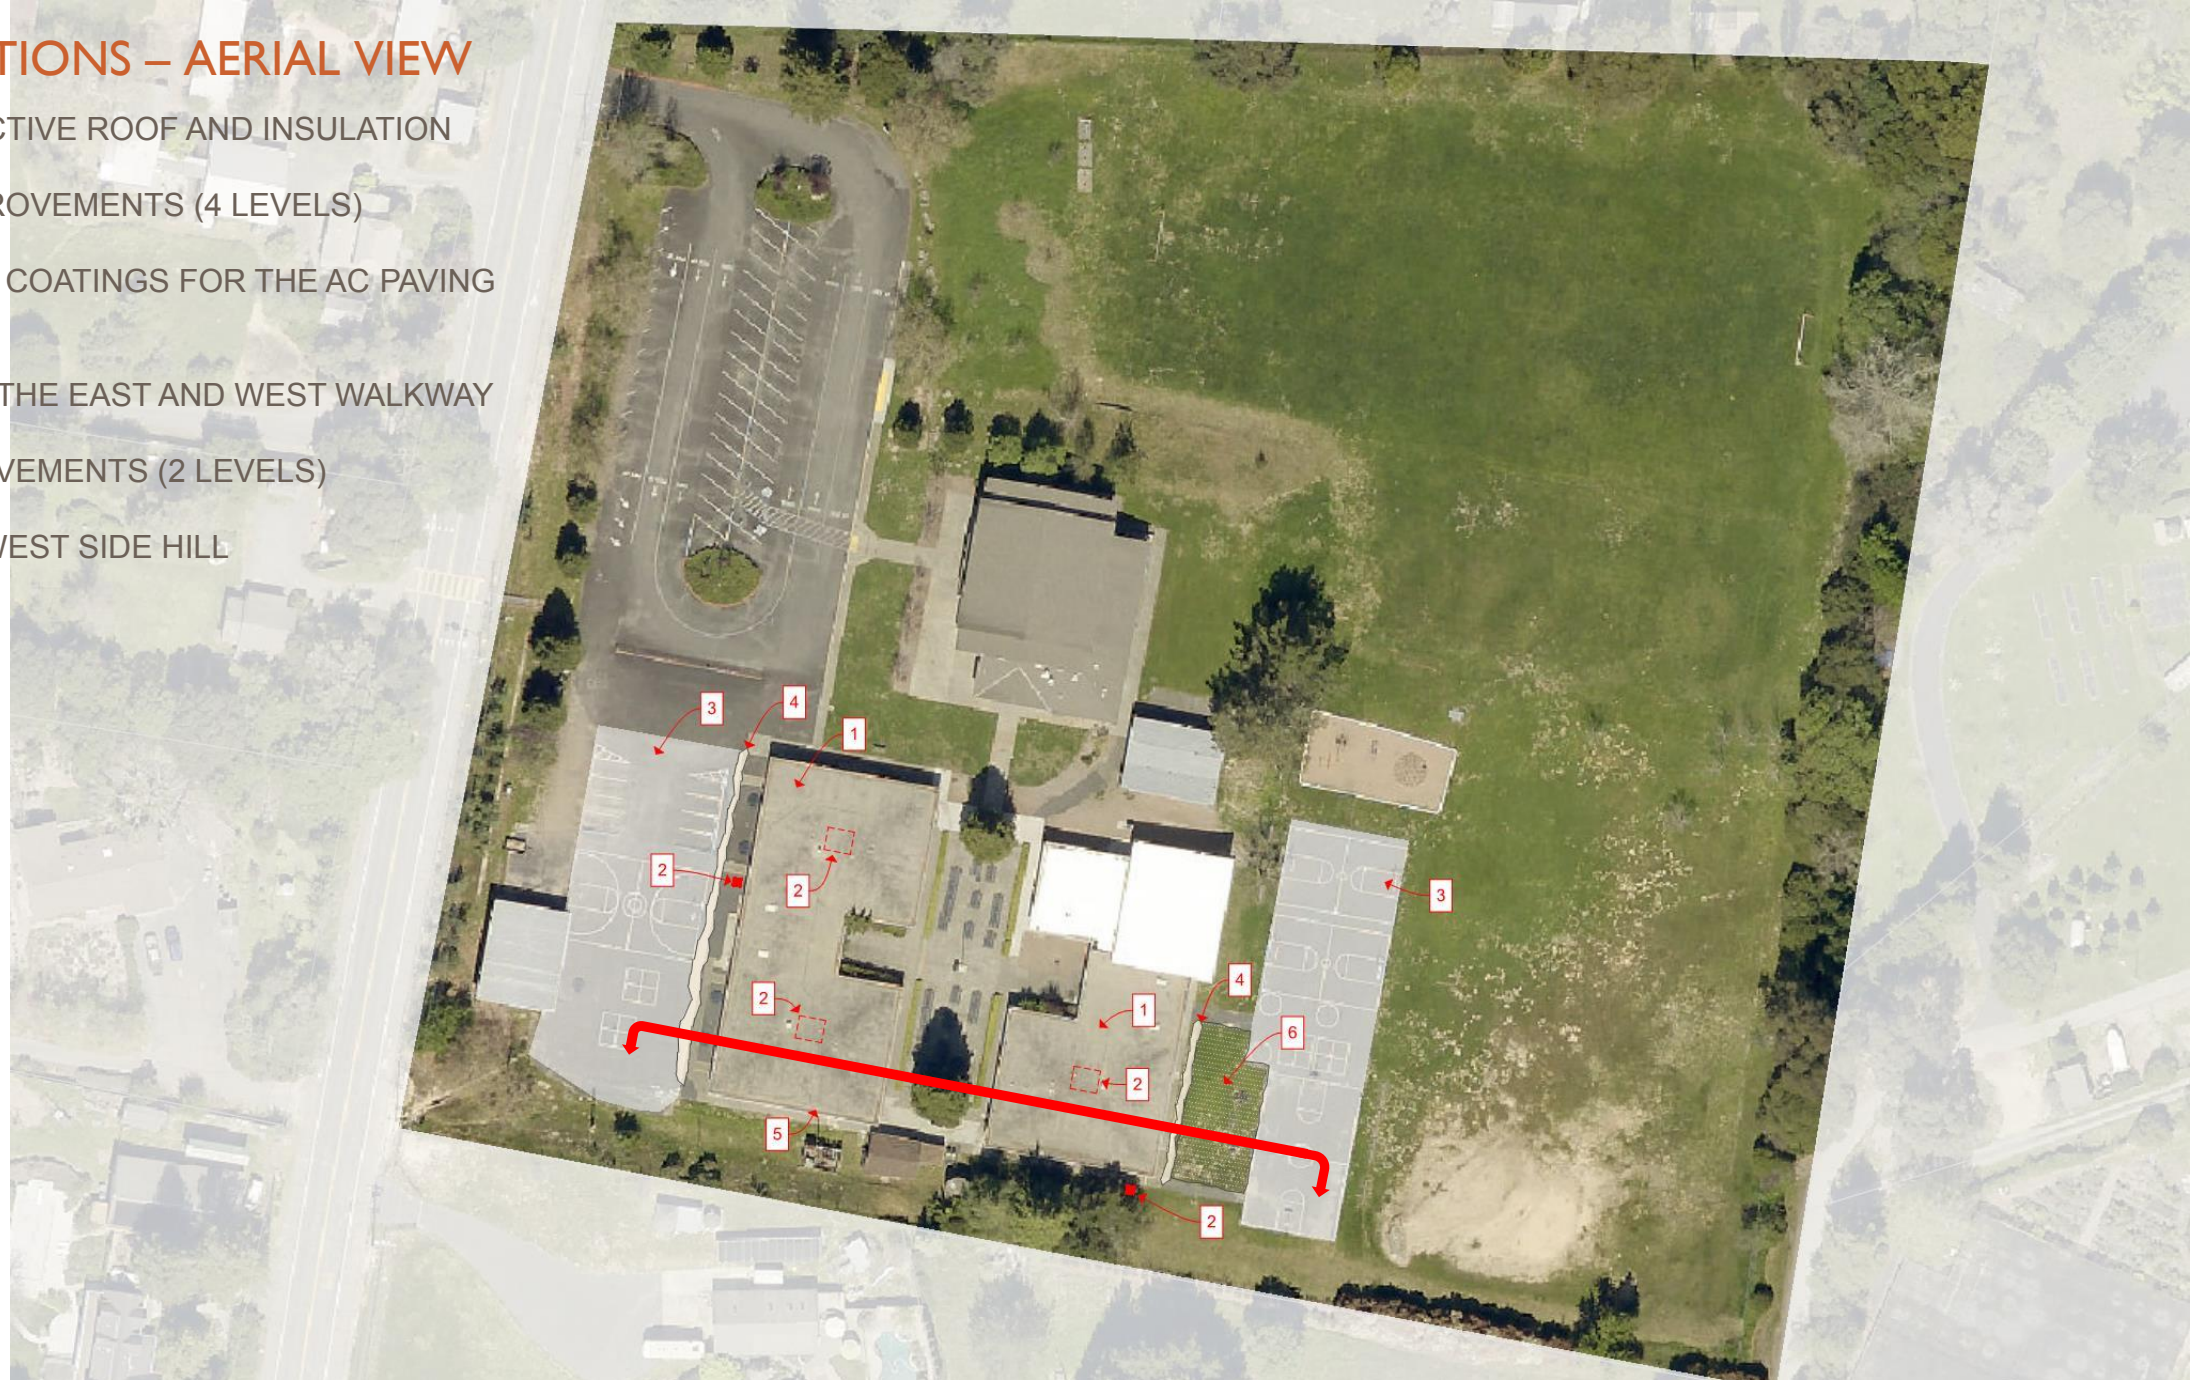
## RECOMMENDATIONS – AERIAL VIEW

1. NEW HIGH REFLECTIVE ROOF AND INSULATION
2. MECHANICAL IMPROVEMENTS (4 LEVELS)
3. HEAT REFLECTIVE COATINGS FOR THE AC PAVING AREAS
4. PLANTING ALONG THE EAST AND WEST WALKWAY
5. ENVELOPE IMPROVEMENTS (2 LEVELS)
6. IRRIGATION FOR WEST SIDE HILL

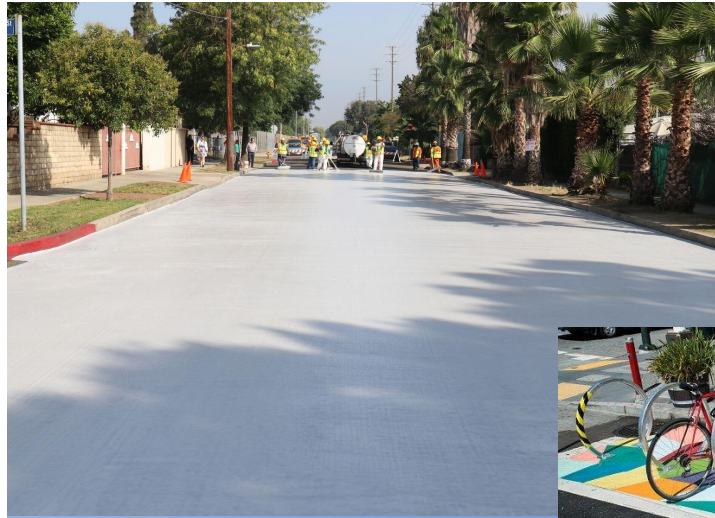
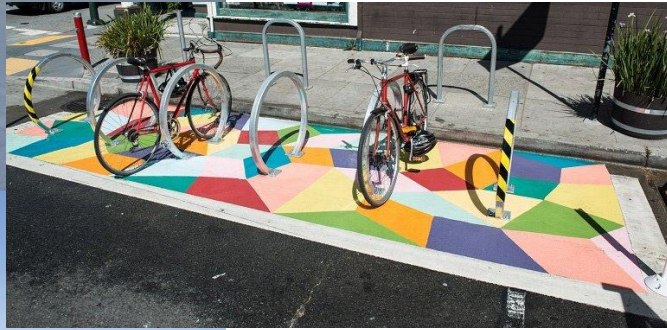
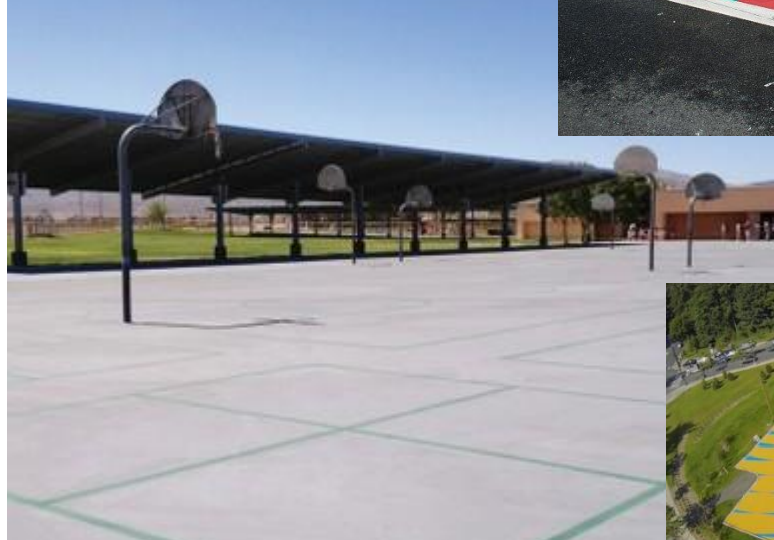
*Examples of Cool Pavement Coatings*

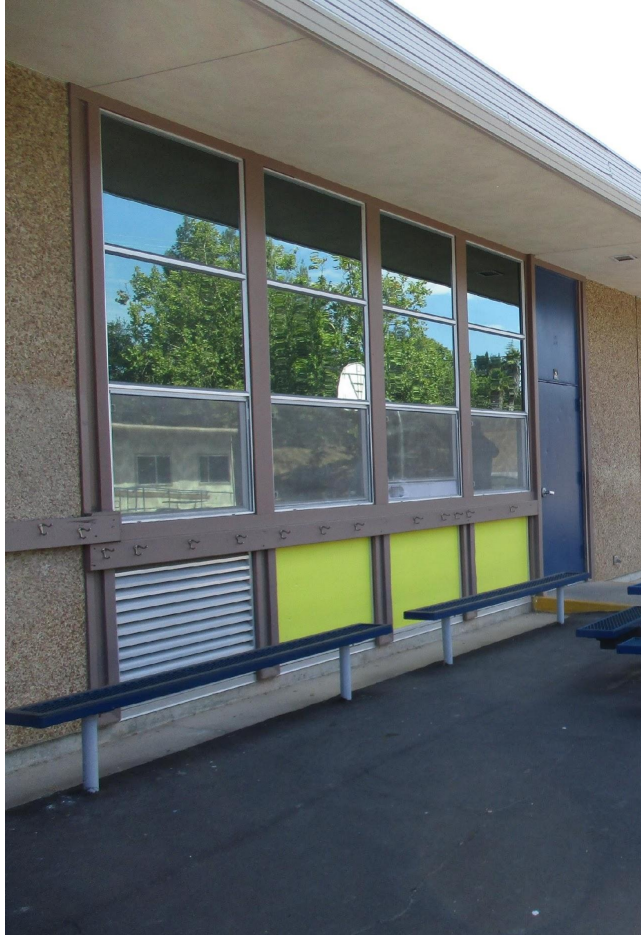
Existing Glazing is single paned glass in a non thermally broken metal framed window system of unknown manufacturer. While in good repair the large window areas with single glazing is allowing a large amount of heat gain into the space and the main point of thermal gain in the existing envelope. The majority of the glass is either West or East facing with limited overhangs. Due to the orientation the gains are early morning or late afternoon with little ability to shade the façade. The roof insulation is minimal, R-19 batt below the deck is estimated based on visual inspection. The wall systems are wood framed and based on the age of the building we're assuming uninsulated. The smaller metal panels within the window systems (Painted yellow in photo below) were uninsulated but normally behind counter and storage pnce on the interior wall Inspection of the wall systems were limited.

*Typical Existing Façade*

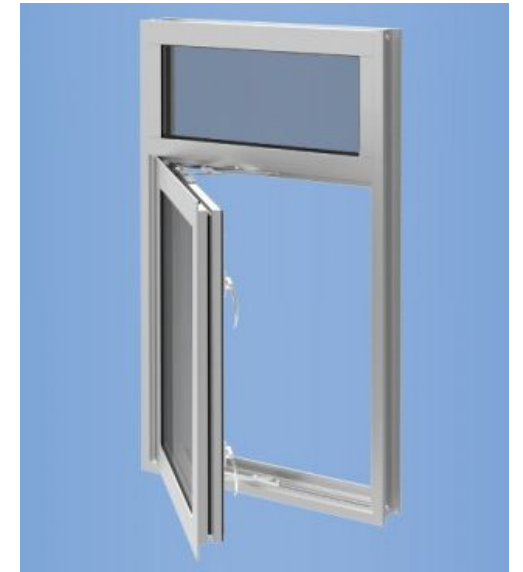
1. Replace the window systems with new insulated low-e glazing in thermally broken framing systems with a U-factor no more than 0.45 and SHGC of 0.25. Casement or other operable windows are recommended for controlling natural ventilation path on days with mild temperatures and good air quality.
2. When Re-roofing add 4 inches of rigid insulation to the roof deck adding approximately R-20 to the roof deck with Cool Roof coating with minimum aged solar reflectance of 0.63 and thermal emittance of 0.75
3. When replacing wall surfaces insulate wall systems with minimum R-13 Batt insulation.

*Example of New Low-E Casement Windows*

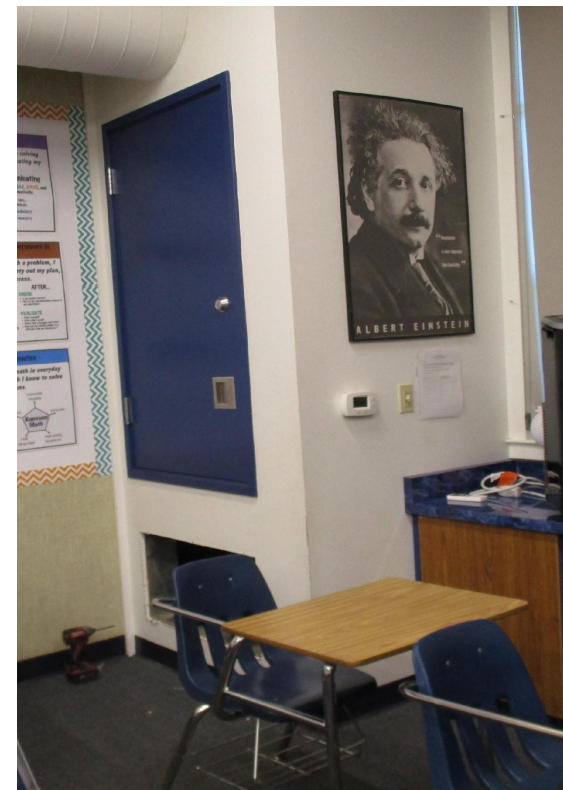
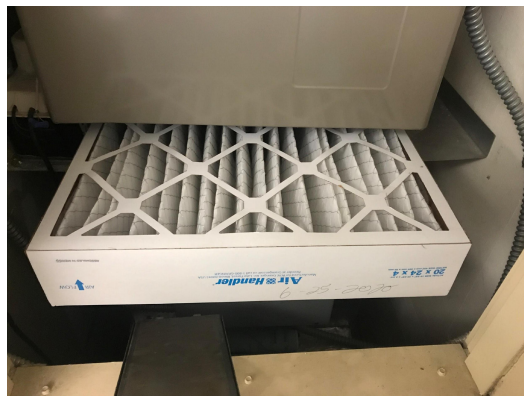
The existing gas fired condensing furnace units are in good working order and are equipped with motorized outside air dampers scheduled to provide between 450 to 550CFM minimum of outside air to each classroom space with economizer capability. Each unit observed appeared to have newly installed 2” MERV 13 filters in place. Digital programmable thermostats were installed in each classroom observed but since most classrooms were un-occupied due to COVID-19 most thermostats were set to run in “Auto” mode and not continuous operation. When set in “auto” mode once space temperatures are met the unit simply shuts off and no ventilation air is provided. Since no air conditioning is installed there is no opportunity to provide fresh air when in “cooling” mode mechanically. Fresh air would only be supplied during these times from open windows or doors with no filtration.

*Typical Gas Fired Furnace Closet & MERV-13 Fresh Filter*

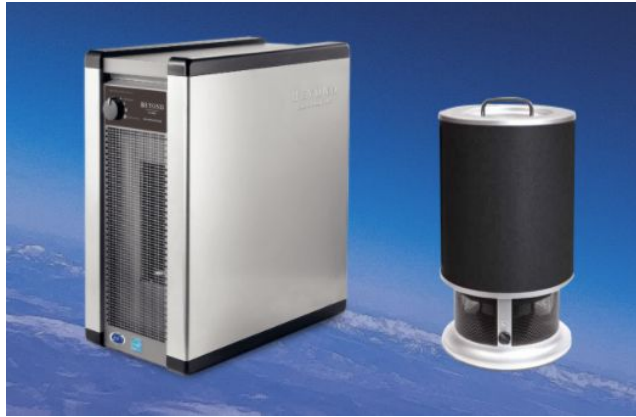
*Examples of Stand Alone HEPA Filtration Systems*

**Option 1:** In addition to the level 2 replacement system, install in room portable HEPA Filtration systems capable of handling the appropriate square footage of the classroom size from 600 SF to 1000 SF. The additional HEPA filtration systems are proven to enhance IAQ in addition to the mitigation measures mentioned in recommendations 1 & 2 on previous pages. This also adds additional comfort level and flexibility of placement within the classrooms near lecture tables and workstations with higher occupant use.

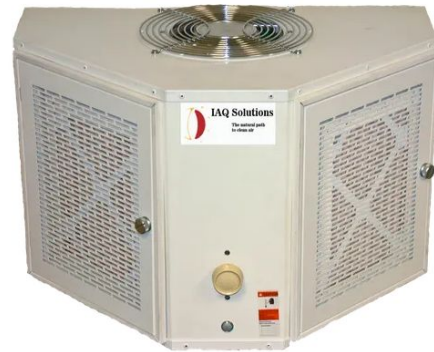
*Room Mounted UVGI System  
(<https://iaqsolutionsinc.net/products> )*

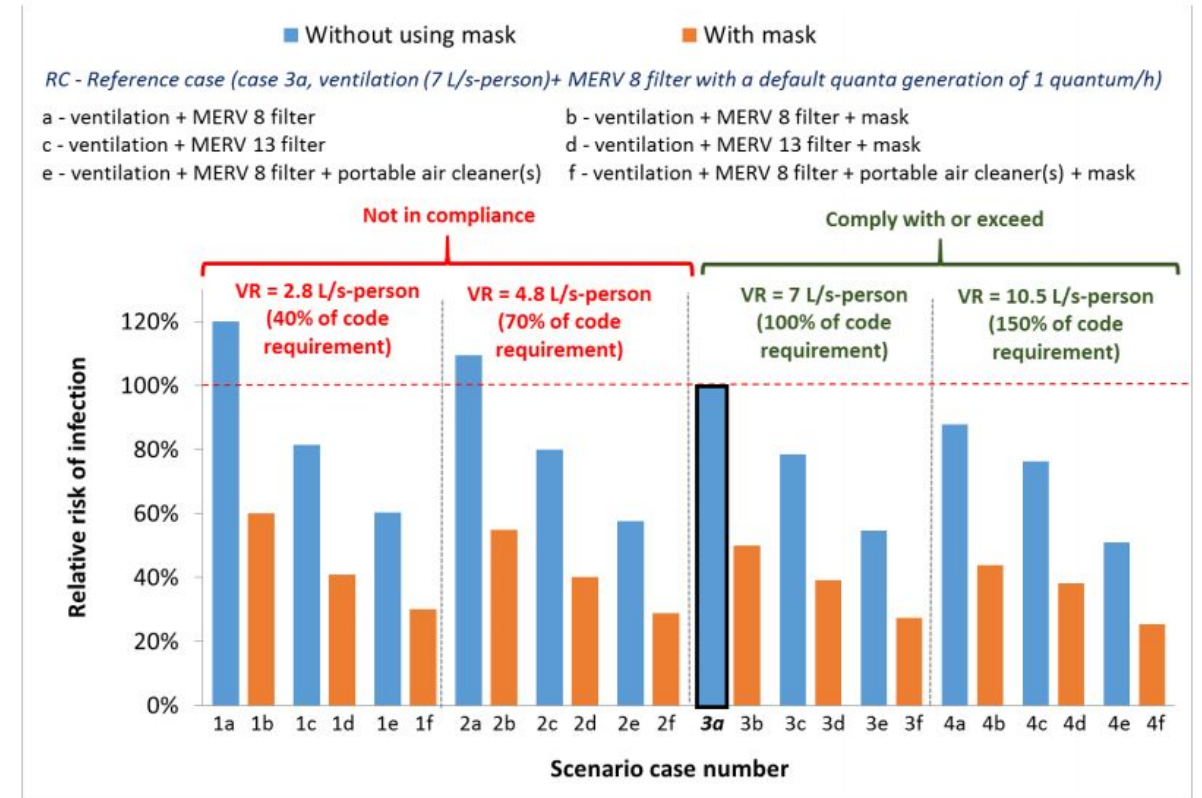
Figure 1: CA Department of Public Health Mitigation Strategies\*

\*Not outlined in this study but supported by the authors a virus transmission risk reduction of just over 30% for portable HEPA Filters with MERV-13 filters in a room designed with minimum ventilation air provided to the space.

While the Science continues on the ways to mitigate COVID-19 in enclosed spaces a handful of tactics are proven facts. Wearing a mask, washing hands, keeping surfaces disinfected all prevent the spread of the Virus. The majority of the spread is from person to person contact and surface, or fomite, transmission. There are various reports linked below with further resources on the topic around airborne transmission and conveyance through the HVAC systems. Throughout these various reports the pattern is similar to these minimum impacts and once established only slight decreases in the rate of transmission are gained going beyond these minimum steps (see Fig.1).
